INDOOR AIR AND SUB-SLAB VAPOR INTRUSION ASSESSMENT

**Meyer Plastics
5968 Sunnyside Road
Lawrence, IN 46236**

BCA Project No. 8092/21-253
IDEM State Cleanup #200610047

**Prepared For:
City of Lawrence
Cooperative Agreement No. BF-00E02707**

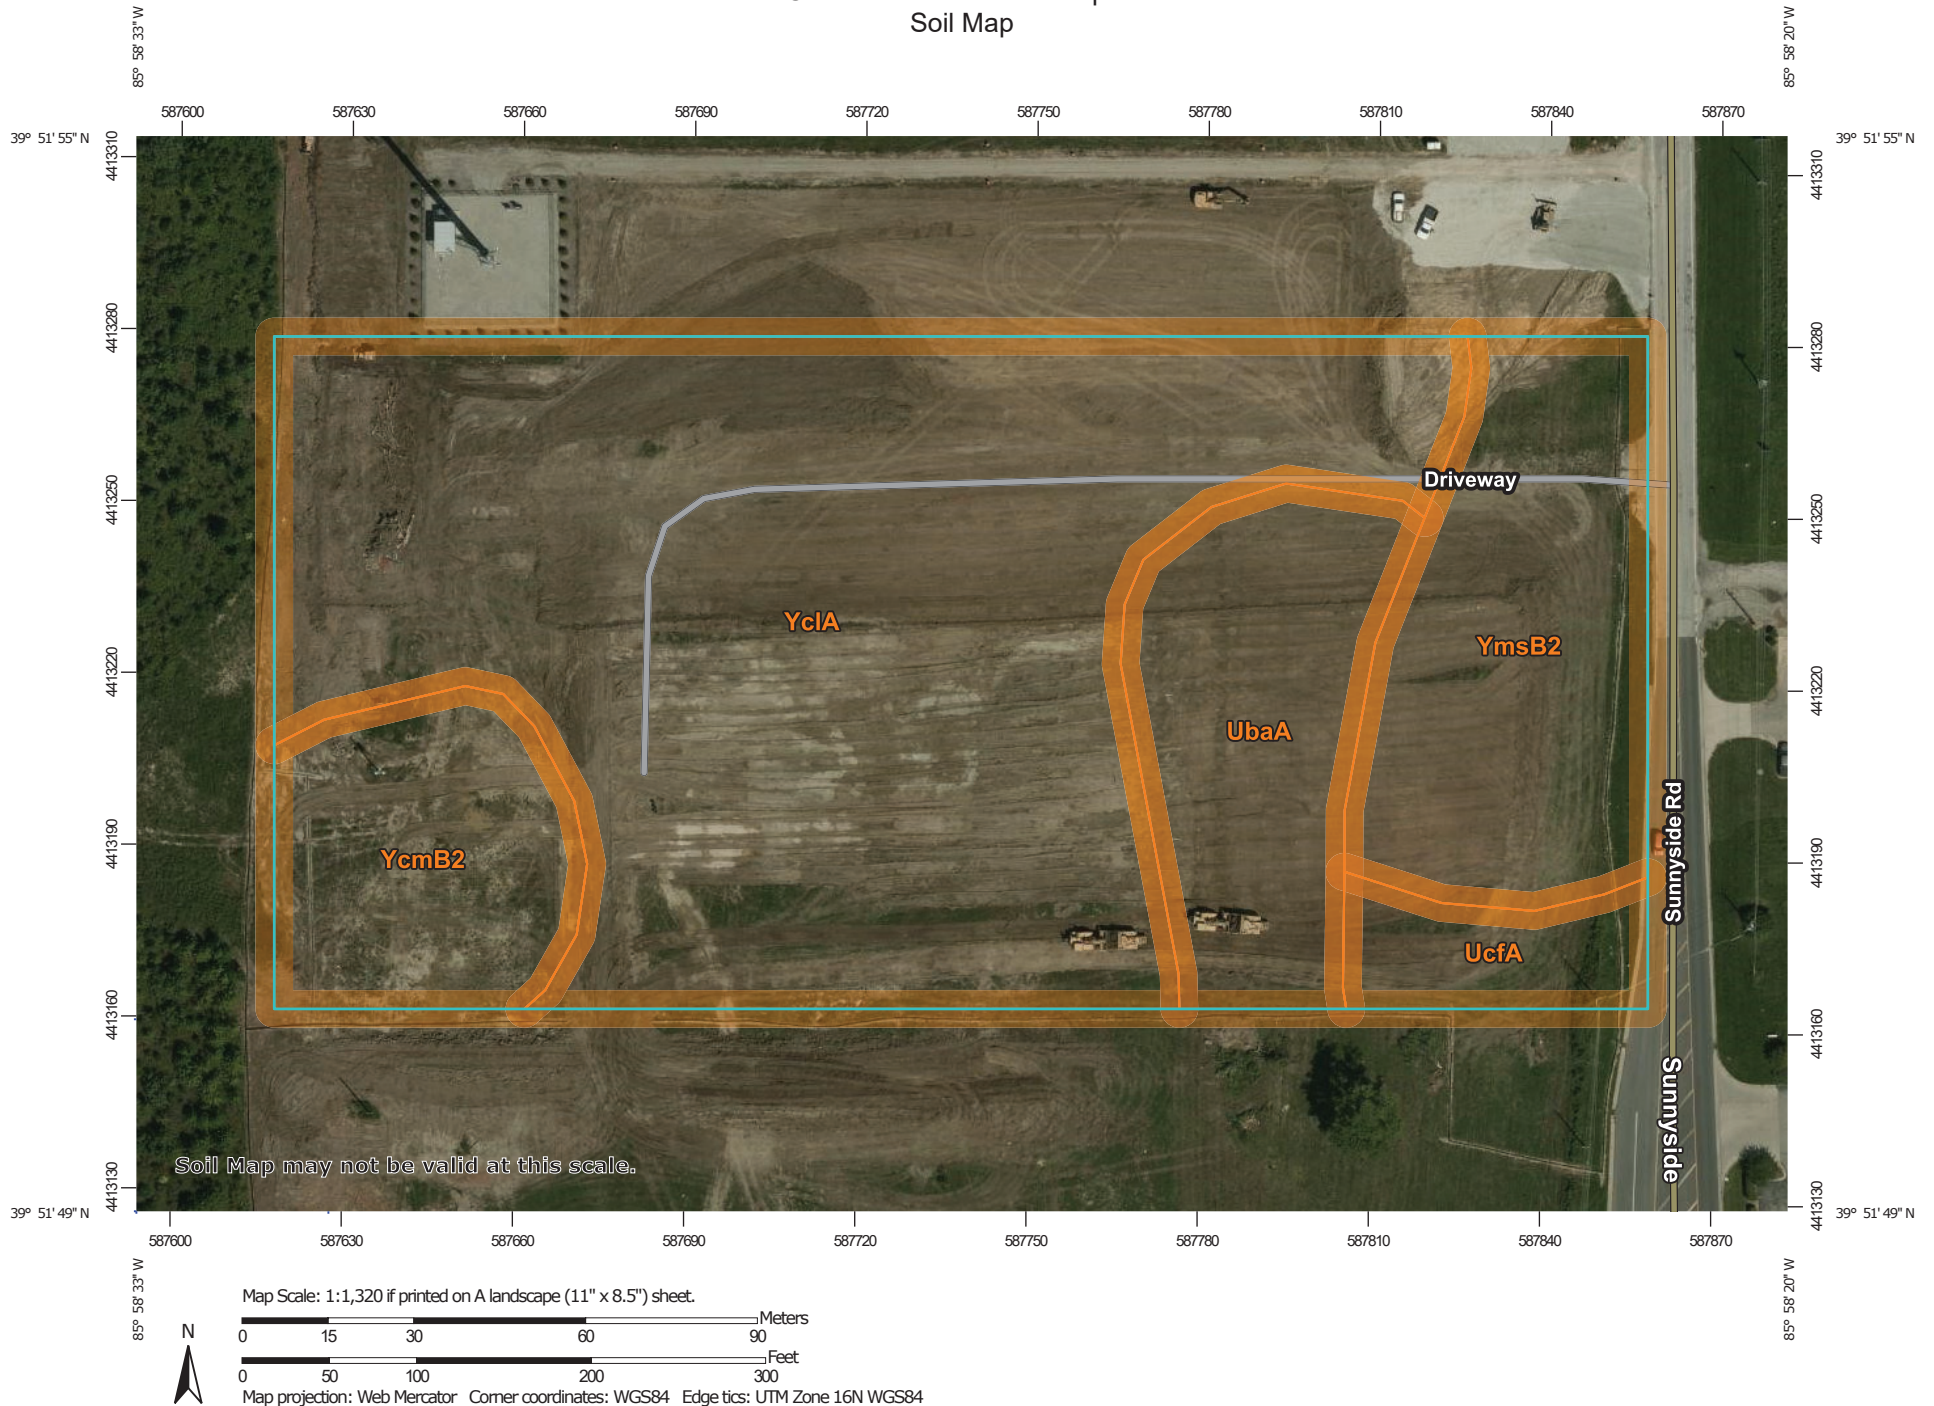
Custom Soil Resource Report Soil Map

The soil map section includes the soil map for the defined area of interest, a list of soil map units on the map and extent of each map unit, and cartographic symbols displayed on the map. Also presented are various metadata about data used to produce the map, and a description of each soil map unit.
